Draft Final Report
4/25/11

**Willett Pond Dam
Phase II Investigation**

Neponset River Land Holding Association

April 25, 2011

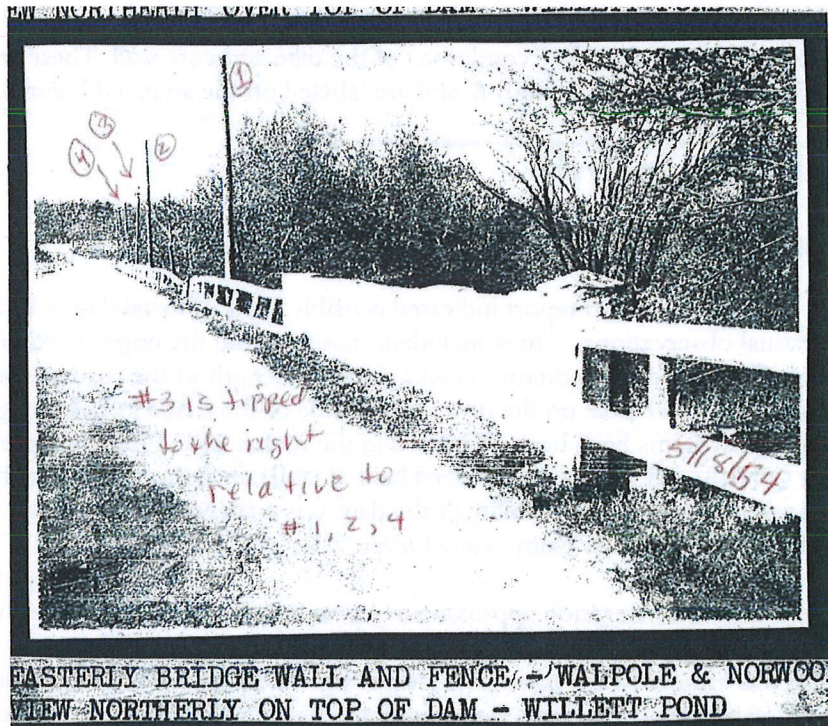
All evidence indicates that the telephone pole cited in the 2007 Phase 1 report as leaning was installed at approximately the current angle. The photo below shows the pole with a traffic sign circa 1954. In the photo, the sign is plumb and level, but at an angle to the axis of the pole,

indicating that the pole was leaning when the sign was installed many years ago. Currently the sign is still level and plumb, and the pole is leaning at the same approximate angle. Adjacent guard rail shows no signs of movement, and the slope itself shows no signs of movement. Therefore there is no visual evidence of slope movement.

Power pole leaning in 1954

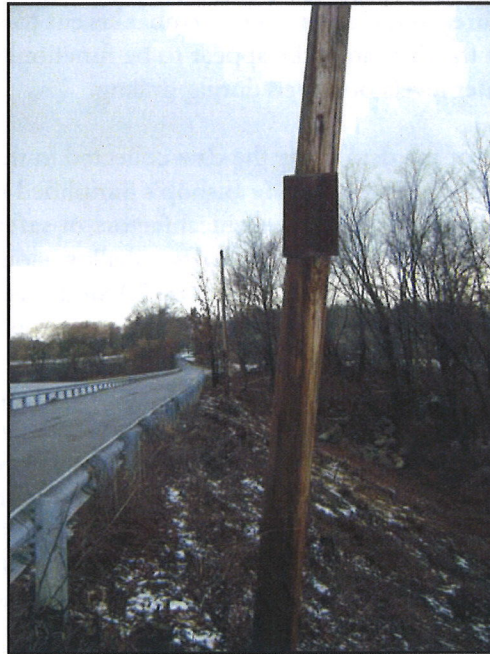
Note old rusted sign – plumb and level and
guard rail – plumb and straight
